NASHUA RIVER BASIN
CLINTON, MASSACHUSETTS

COACHLACE POND DAM
MA 00106

**PHASE I INSPECTION REPORT
NATIONAL DAM INSPECTION PROGRAM**

OCTOBER 1978

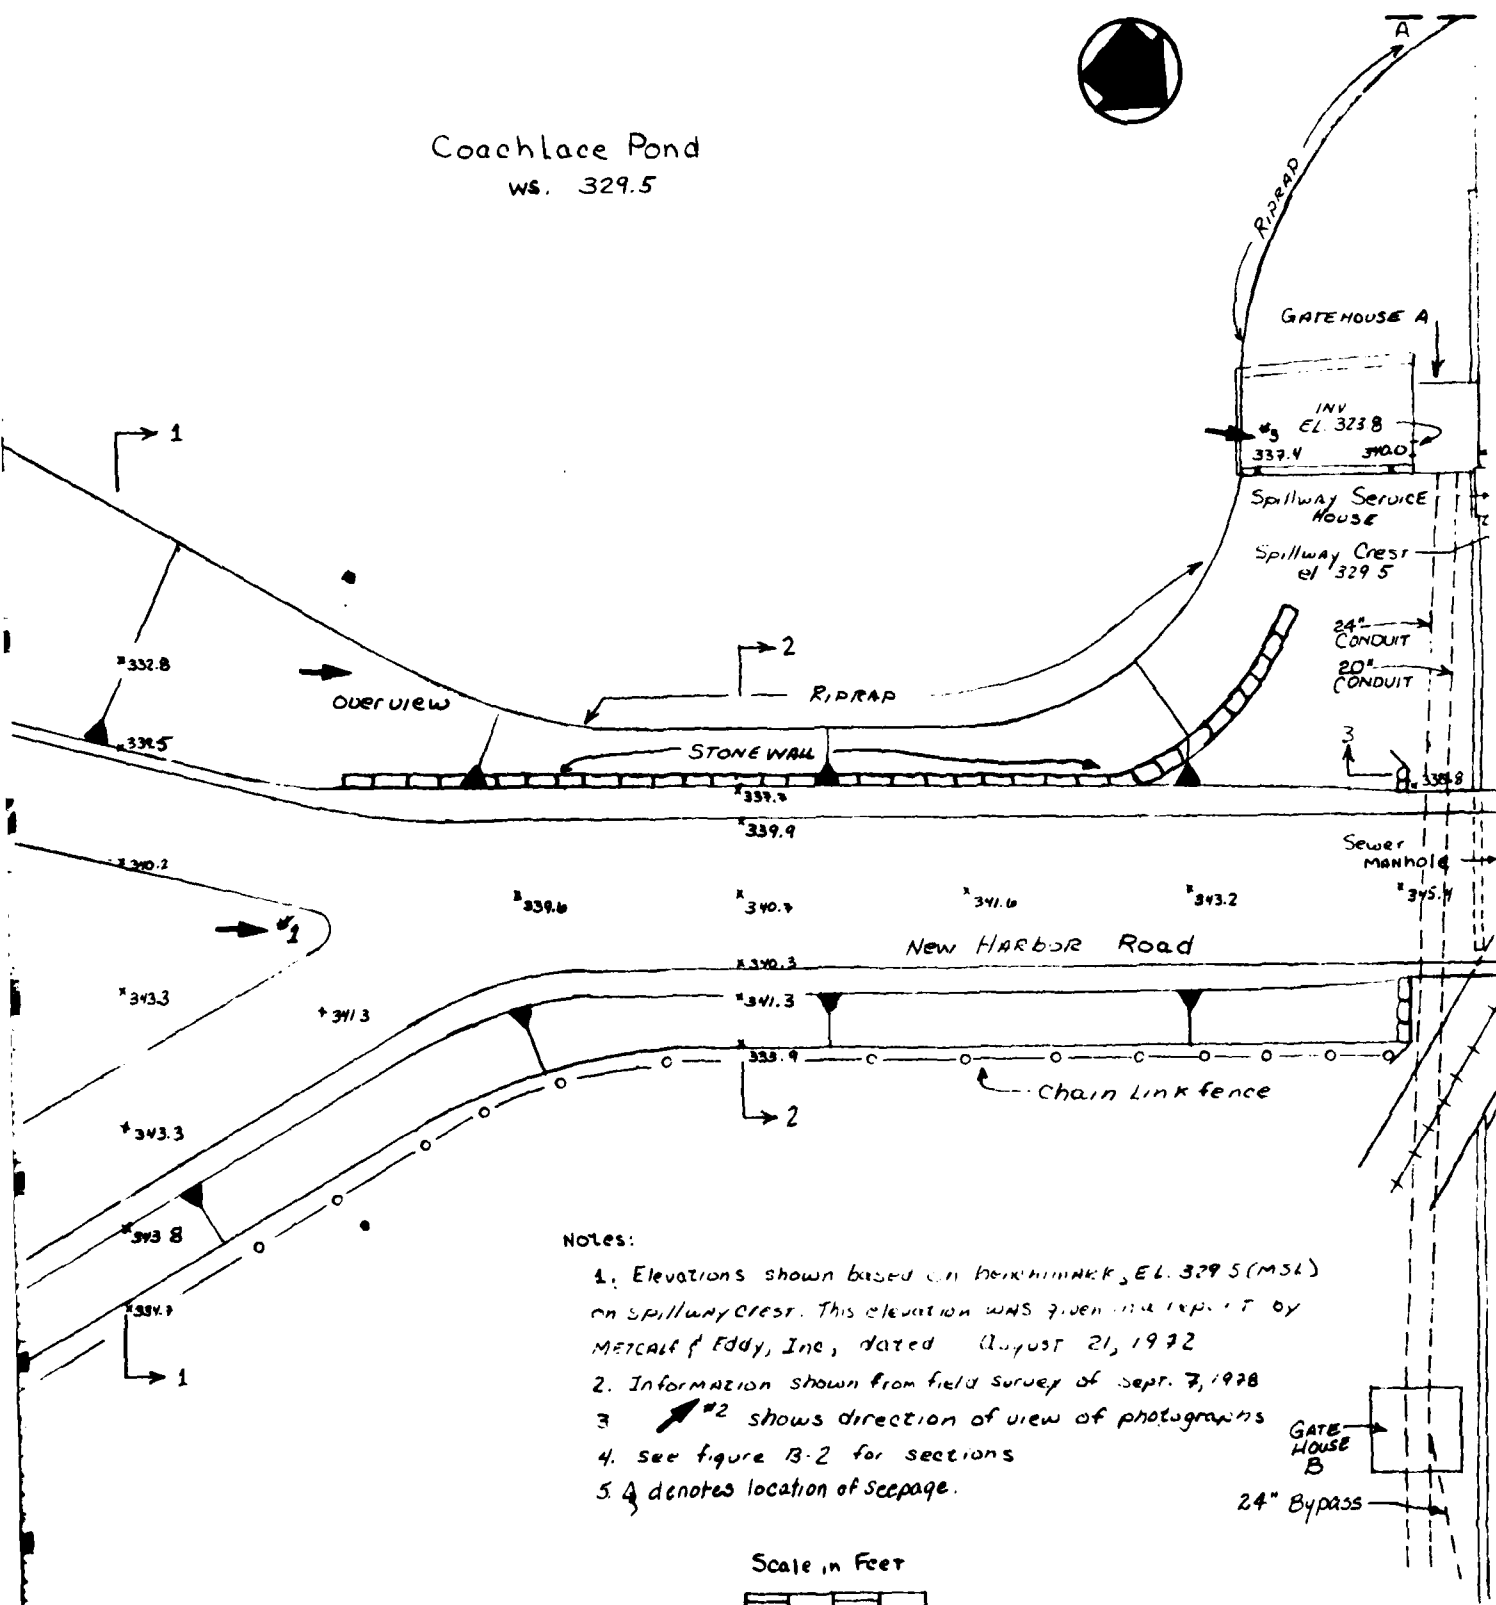
1. Elevations shown based on benchmark, EL. 329.5 (MSL) on spillway crest. This elevation was given in a report by METCALF & Eddy, Inc., dated August 21, 1972
2. Information shown from field survey of Sept. 7, 1978
3. #2 shows direction of view of photographs
4. See figure B-2 for sections
5. 4 denotes location of seepage.
